Manhole Inspection Summary

Manhole # S31GG1003MH

Insp Date: **1/8/07 6:45 AM**

Location Address: **221 STONEYFORD RD**

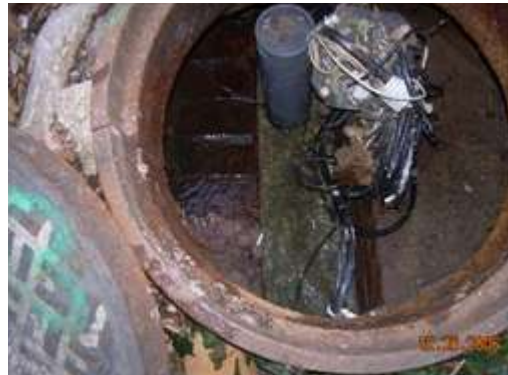
Top View

Frame Offset: **0** (in.) Condition: ☐ Sound ☒ **Cracked** ☐ Leaks

Bench ☒ Exists Material: **Brick** ☐ Parged ☒ **Debris** (not Condition related)

Cracked frame. Bench debris.

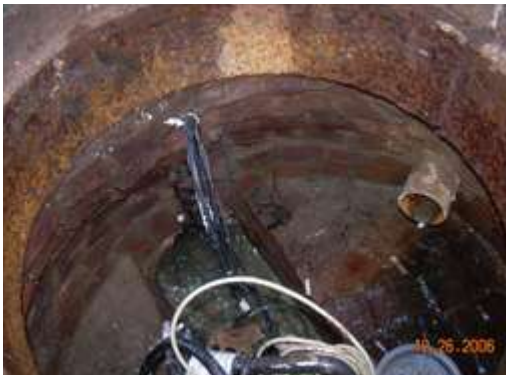
View of the I6 and the I8

Infiltration: ☐ None ☒ **Joint** ☐ Cracks ☐ Mortar ☐ Roots ☒ **Wall**

Infiltration: ☐ None ☐ Joint ☐ Cracks ☒ **Mortar** ☐ Roots ☒ **Wall**

Corbel deterioration and infiltration. Barrel infiltration.

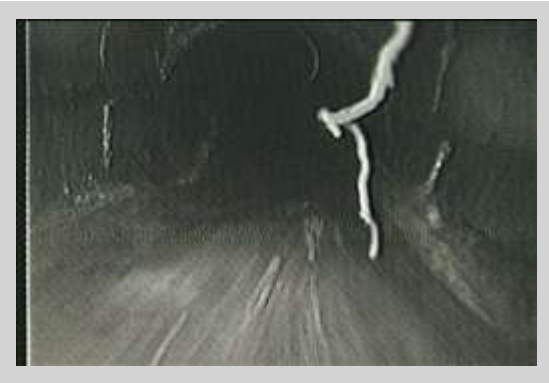
10 in. Circular Gravity Sewer Pipe Out @ 12 O'Clock

Pipe Material: **Clay** ☐ Pipe Lined

Invert Depth: **4.05** (ft.) Flow Characteristics: **Fast**

Deposits: ☒ None ☐ Mud ☐ Sludge ☐ Debris ☐ Grease

Infiltration: **None** Pipe Seal Cond: **Unknown**

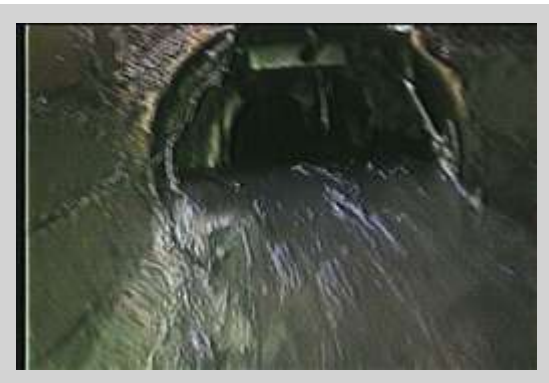
10 in. Circular Gravity Sewer Pipe In @ 6 O'Clock

Pipe Material: **Clay** ☐ Pipe Lined

Invert Depth: **3.43** (ft.) Flow Characteristics: **Fast**

Deposits: ☒ None ☐ Mud ☐ Sludge ☐ Debris ☐ Grease

Infiltration: **None** Pipe Seal Cond: **Unknown**

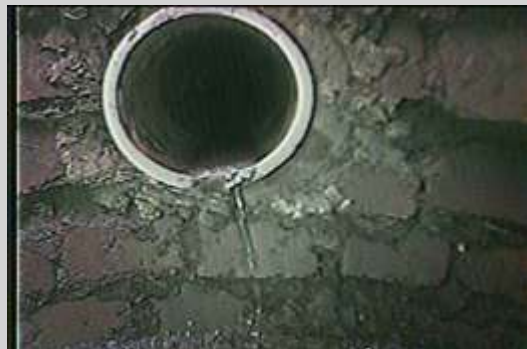
4 in. Circular Gravity Sewer

Pipe Material: **Clay**

Invert Depth: **2.60** (ft.) Flow Characteristics: **Slow**

Infiltration: **Evidence**

Connects To: **House connection / Service line**
